POTENTIAL HAZARDOUS WASTE SITE
IDENTIFICATION AND PRELIMINARY ASSESSMENT

A. SITE NAME Wood Protection Company		B. STREET (or other identifier) 5151 South Loop East	
C. CITY Houston	D. STATE Texas	E. ZIP CODE 77033	F. COUNTY NAME Harris
G. OWNER/OPERATOR (if known) 1. NAME Marc Hoover, General Manager		P.O. Box 33376 Houston, TX 77033	2. TELEPHONE NUMBER (713) 233-7421
H. TYPE OF OWNERSHIP <input type="checkbox"/> 1. FEDERAL <input type="checkbox"/> 2. STATE <input type="checkbox"/> 3. COUNTY <input type="checkbox"/> 4. MUNICIPAL <input checked="" type="checkbox"/> 5. PRIVATE <input type="checkbox"/> 6. UNKNOWN

RCRA 3012 PRELIMINARY ASSESSMENT COMMENTS
WOOD PROTECTION COMPANY
HOUSTON, TEXAS
HARRIS COUNTY

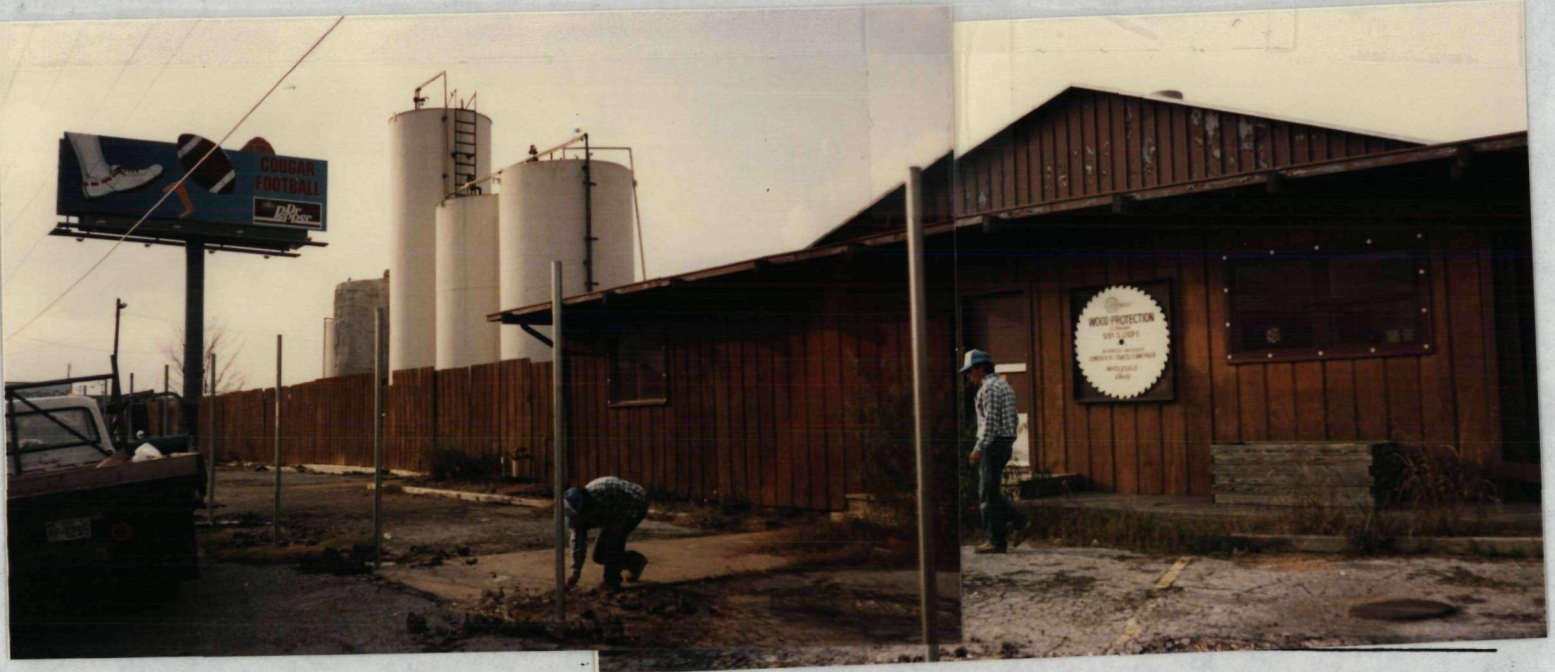
The surveillance revealed that the plant is enclosed by a wooden privacy fence. Five upright white tanks, lumber shelters, a treatment area, and the main office were observed. Details of the treating area were not visible. Surrounding land uses are commercial and residential.

Comments: Front of facility

from South Loop 610

The site has undergone one TDWR solid waste compliance inspection. The file information indicated that TAC deficiencies determined from the inspection were cleared up by the company. Although treatment chemicals are apparently reused in the process, a low priority site inspection is recommended to confirm past and present waste management practices and to determine whether nearby surface or groundwaters could be impacted by the facility.
